Manhole Inspection Summary

Manhole # S25K__016MH

Insp Date: **7/7/09 9:43 AM**

Location Address: **1261 W.Pratt St.**

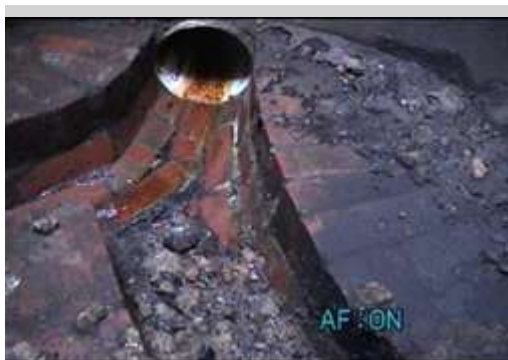
Miscellaneous

debris on bench and in the channel

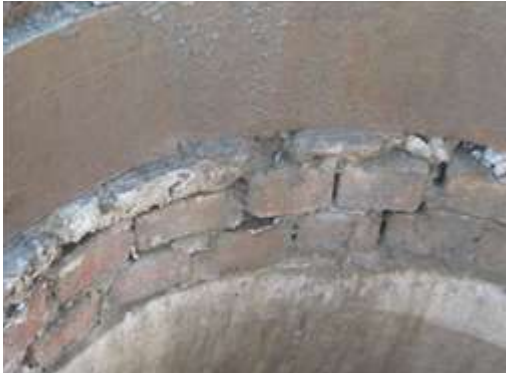
Defect 8

Chimney / Frame Adjustment ☒ Exists Material: **Brick** ☐ Parged Height: **8** (in.)

Condition: ☐ Sound ☐ Cracked ☐ Root Intrusion ☒ **Loose Brick** ☐ Deteriorated

Infiltration: ☐ None ☐ Joint ☐ Cracks ☒ **Mortar** ☐ Roots ☐ Wall

chimney infiltration and loose bricks

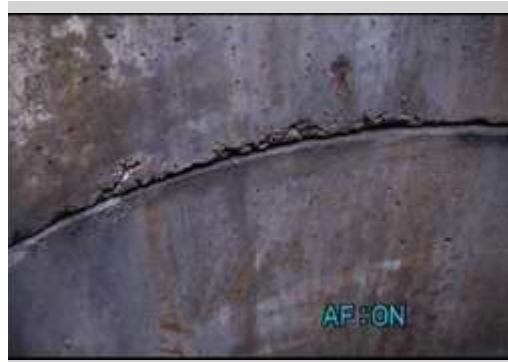
Defect 5

Infiltration: ☐ None ☒ **Joint** ☐ Cracks ☐ Mortar ☐ Roots ☐ Wall

evidence of infiltration at the corbel/barrel joint

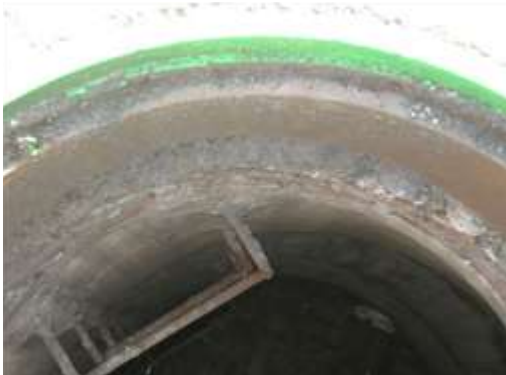
Defect 2

Frame Offset: **1** (in.) Condition: ☒ Sound ☐ Cracked ☐ Leaks

frame offset

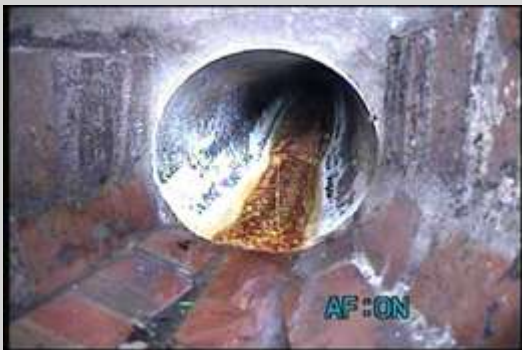
12 O'Clock Outflow

8 in. Circular Gravity Sewer
Pipe Out @ 12 O'Clock

Pipe Height: **8.4** (in.) Rod and Bar (Angled)
Pipe Material: **DIP/CI** ☐ Pipe Lined
Invert Depth: **9.00** (ft.) Flow Characteristics: **None**
Deposits: ☒ None ☐ Mud ☐ Sludge ☐ Debris ☐ Grease
Silt Depth: **0** (in.) Deposits Extent:
Infiltration: **None** Pipe Seal Cond: **Sound**

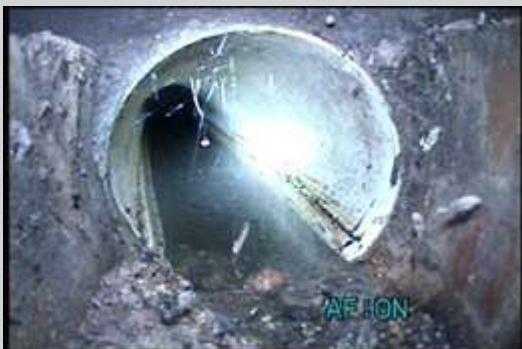
4 O'Clock Inflow

8 in. Circular Gravity Sewer
Pipe In @ 3 O'Clock

Pipe Height: **8.4** (in.) Rod and Bar (Angled)
Pipe Material: **PVC** ☐ Pipe Lined
Invert Depth: **8.70** (ft.) Flow Characteristics: **None**
Deposits: ☒ None ☐ Mud ☐ Sludge ☐ Debris ☐ Grease
Silt Depth: **0** (in.) Deposits Extent:
Infiltration: **None** Pipe Seal Cond: **Sound**

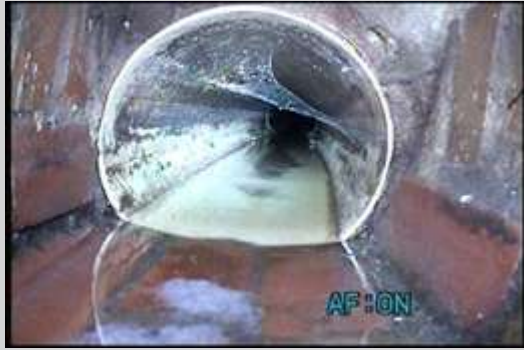
8 O'Clock Inflow

8 in. Circular Gravity Sewer
Pipe In @ 9 O'Clock

Invert Depth: **8.92** (ft.) Flow Characteristics: **Slow**

Infiltration: **None** Pipe Seal Cond: **Sound**
